KENTUCKY COUNCIL ON POSTSECONDARY EDUCATION
FINANCE COMMITTEE MEETING

TITLE: Proposed Raze and Replace Asset Preservation Pool Project:
Somerset Community College, Laurel South Campus, Phases I and II

Laurel South Feasibility Study

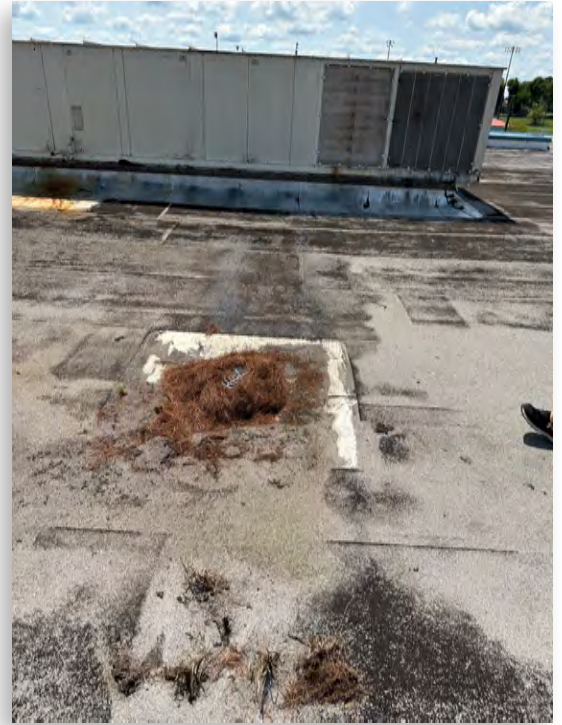
The problem with the blocked roof drains was consistent on the roof of the 1975 addition. All four of the roof drains were covered in pine needles and surrounded by piles of granules. The discoloration of the roof where the granules have become dislodged, exposing the modified bitumen membrane to UV light is also apparent here. Note the mechanical curb under the unit in the background: with the addition of new roof insulation there will be little room to properly flash the curbs into the roof system. All roof penetrations will need to be extended to the new roof level.

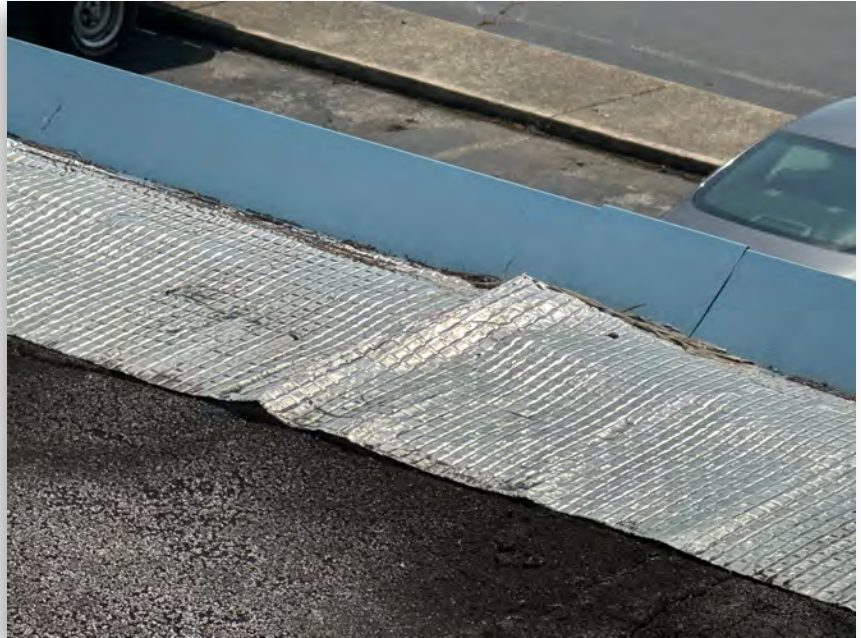
The foil-faced flashing at the roof perimeter is pulling up and damaged in many places. The gaps in the flashing where the material has stretched shown here, allow water to penetrate and enter the wall cavity

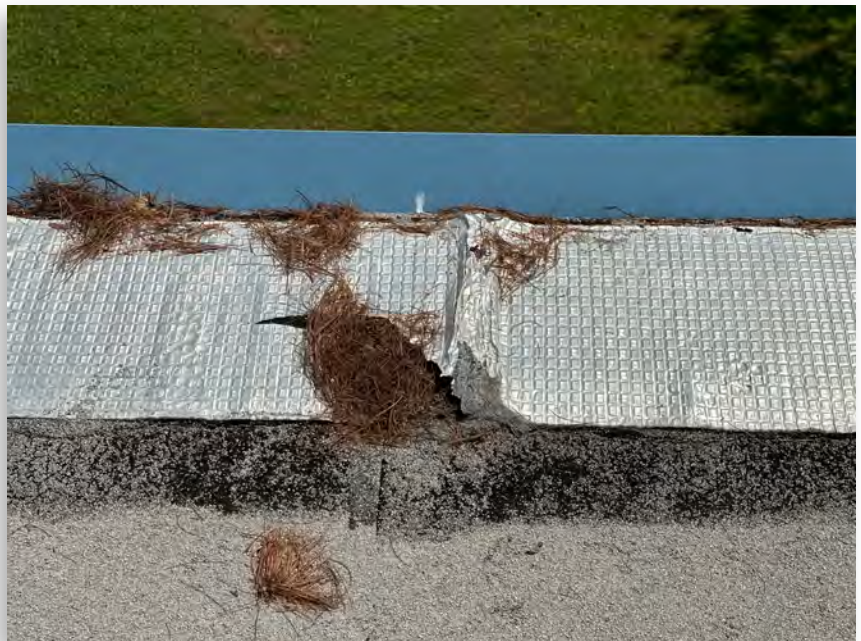
In other places, the flashing material is torn or missing. Here it appears to have snagged pine needles at the roof edge.

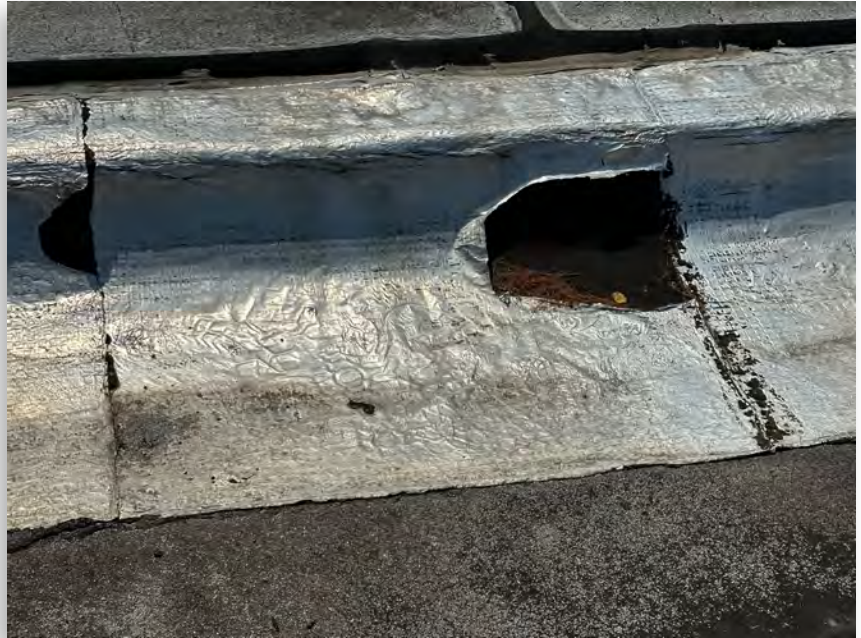
The damage to the foil-faced flashing is pervasive. WPA documented many conditions like the ones shown at roof edges, mechanical curbs and other features.

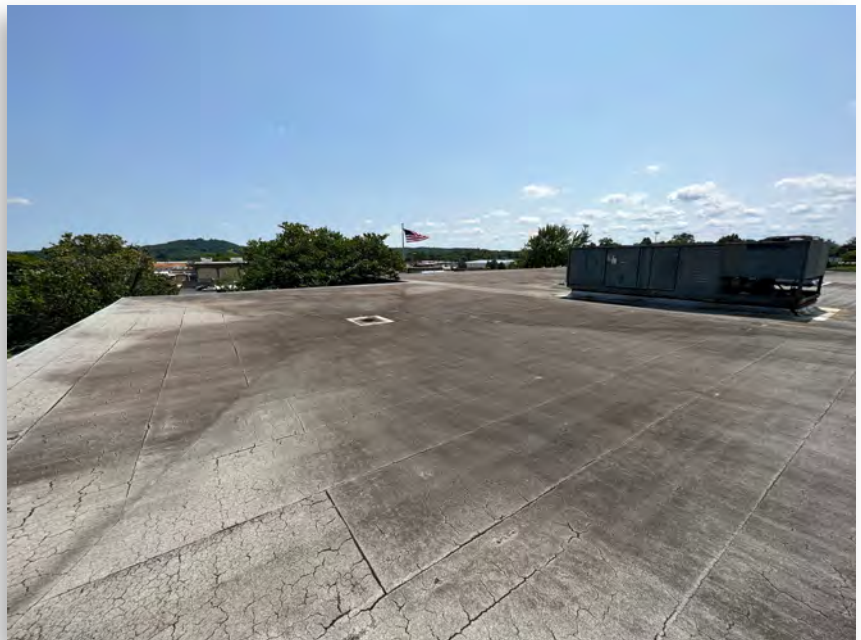
This overview of the original building's roof shows the state of the existing roof. Dark areas are places where the roof has lost granules. In the foreground extensive cracking of the membrane is visible. The low curbs on the mechanical unit on this portion of the roof is also visible. The roof drains on the original building do not seem to suffer from the presence of debris like the 1975 roof. The original building also has significantly more roof drains on its smaller area.

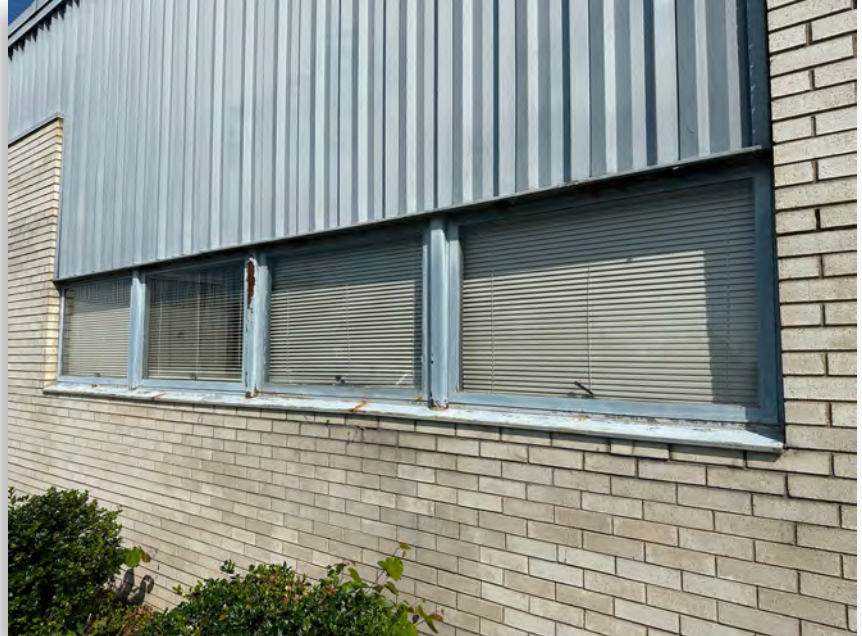
This is a typical steel window showing signs of rust in multiple places. These windows are uninsulated and not thermally broken allowing for thermal bridging that can cause condensation in the winter and summer. WPA recommends these windows be replaced with energy efficient ones. Note the discoloration in the bricks below the window and in a horizontal band at the left side near the window head. These are the signs that water is accumulating in the wall cavity.

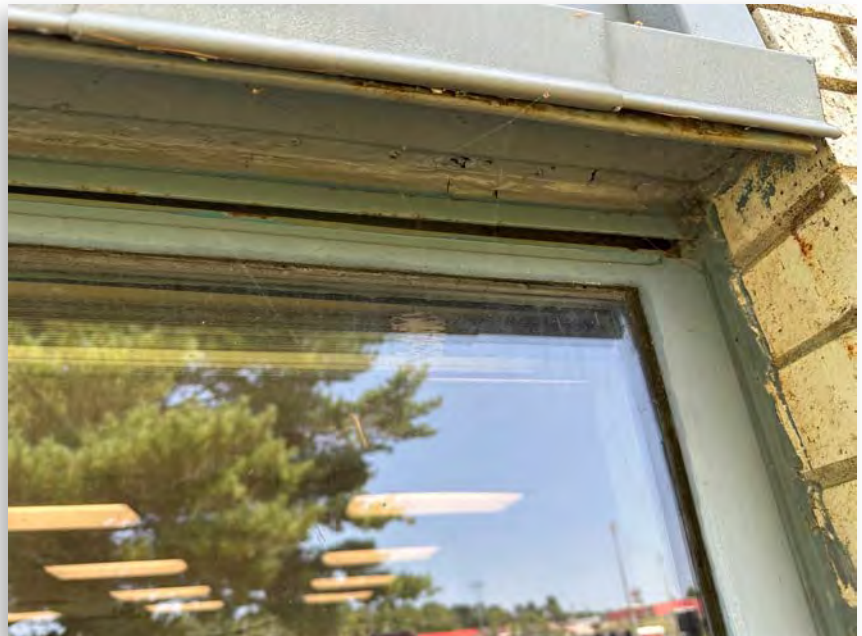
This steel window has a damaged sash that does not seal properly. There are signs of rust in the gap at the top.

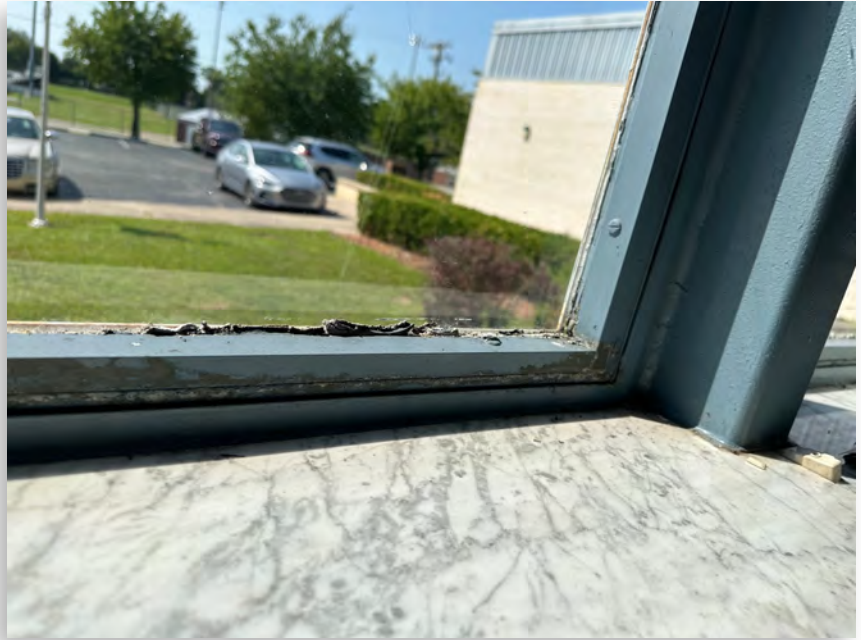
This image shows the deterioration of the glazing sealant in this window. The bottom of the sash is also showing significant wear.

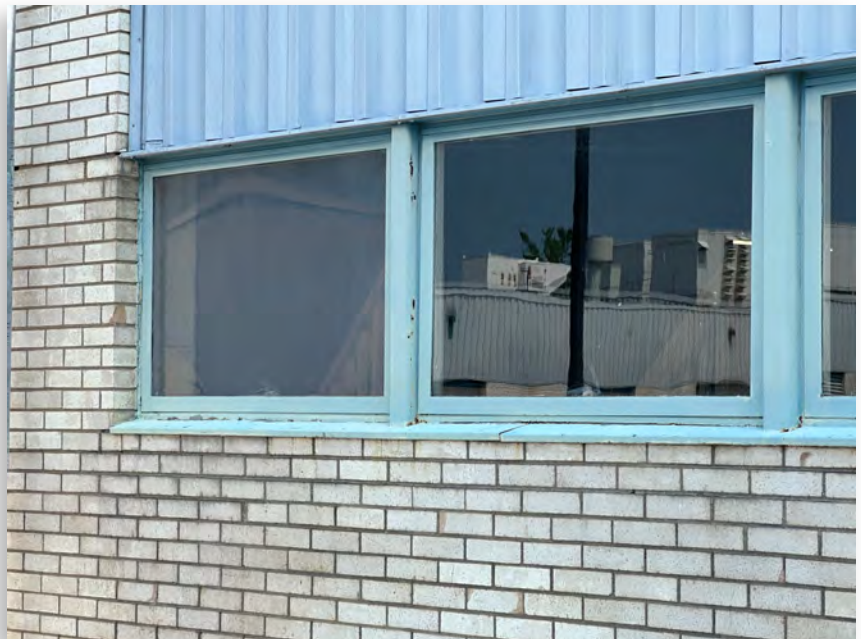
This image shows another window with rust in various places. This window also has a damaged sill that is allowing moisture into the wall cavity below the window. Note the gap between sill lengths under the middle sash.

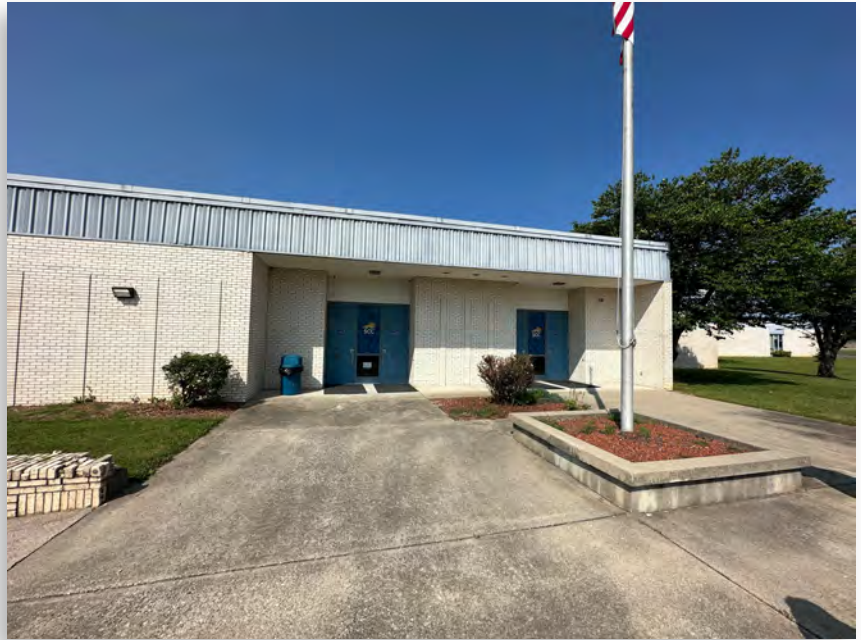
This is the main entry to the Laurel South Campus. The two pairs of doors – each separated by a sidelite – are flush hollow-metal doors. In addition to being in bad shape, these doors do not provide an appropriate first impression to the campus.

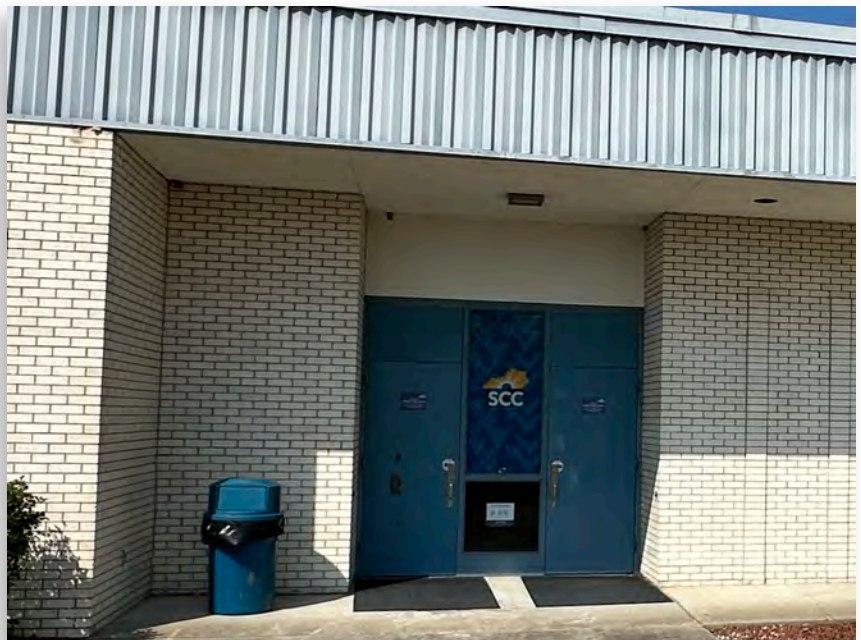
This enlarged section of the previous image shows the damage to the doors and the infilled transoms above each door. Most outward-swinging exterior doors are also showing rust on the hinges as well as the bottoms of many frames. The configuration shown here is typical at most entries.

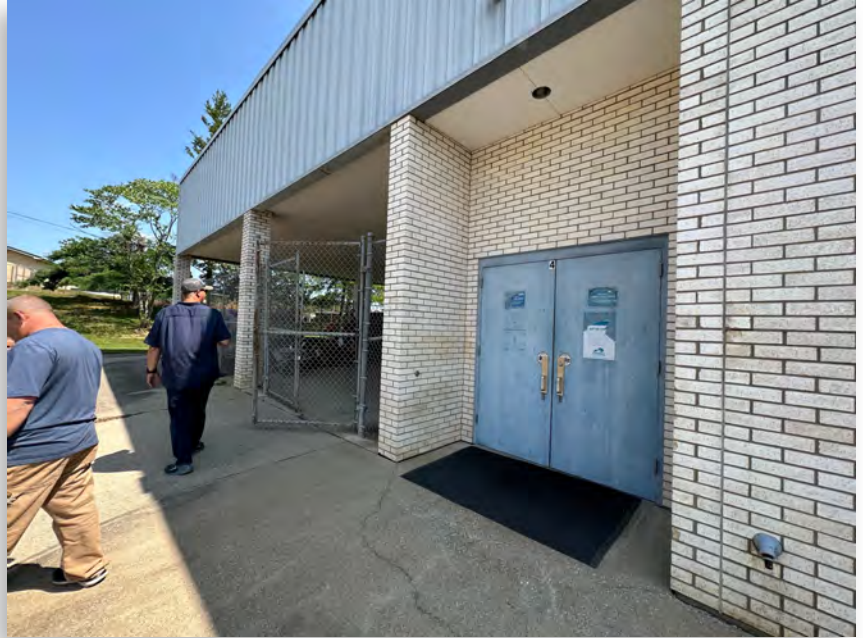
All exterior hollow-metal door frames have a 4" head. Many doors like these have been fitted for multiple hardware sets over the years and were not typically repainted to cover the locations of old hardware. The doors here at the end of the main corridor in the 1975 addition are in particularly good shape.

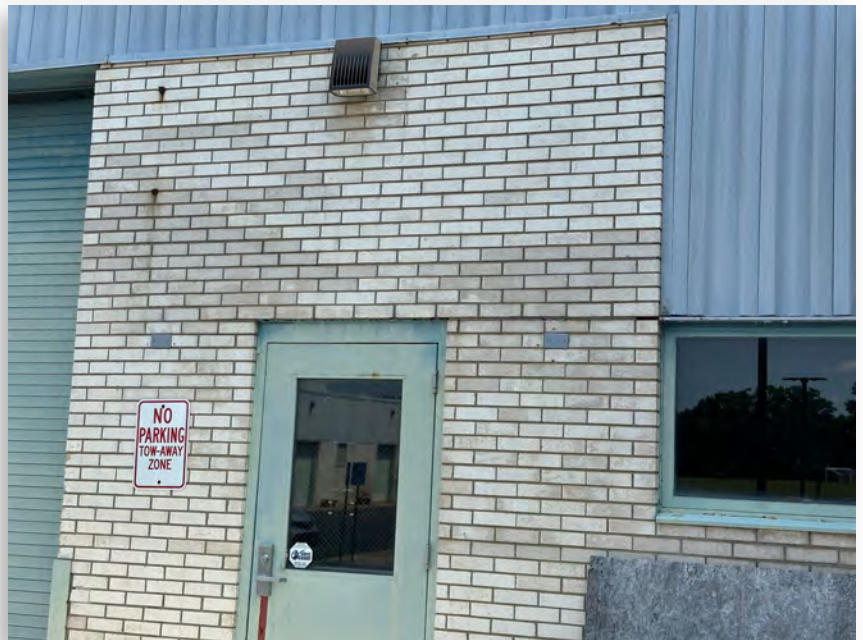
This door into the carpentry shop area shows bare metal where an old lockset was removed. There is rust on the panel at the lite kit and the lintel above the door is rusted. The discolored bricks above the lintel hint that water in the wall cavity has collected there, causing the lintel to rust and swell which is also causing the mortar joint to pop out. Water stains on the frame head also indicate that water has worked its way out below the lintel.

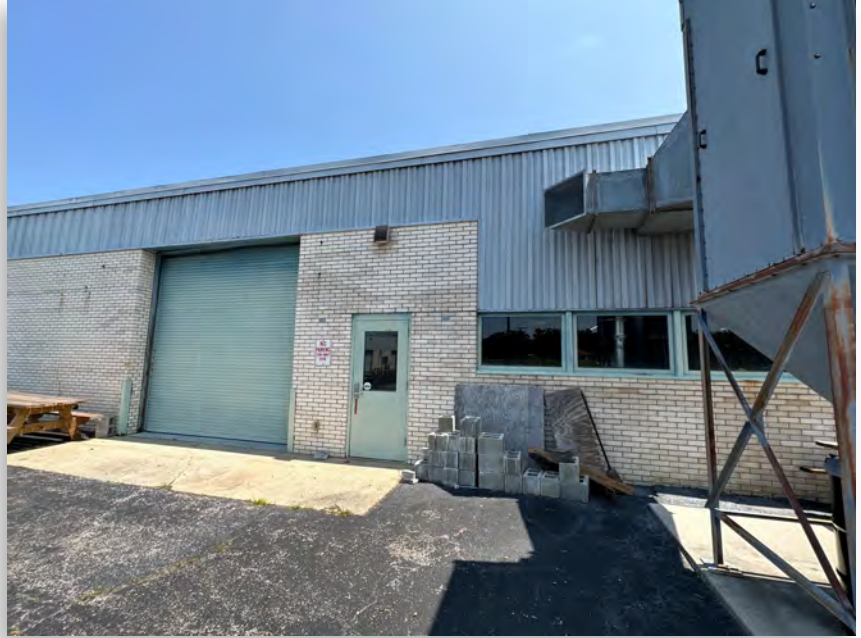
The over-head coiling garage doors typically extend to the top of the brick as shown here on the original 1971 building. The jamb on the left side of the door is showing rust which begins about 32" below the top of the brick. A line of discolored bricks to the left of the door suggests there is a relief angle there collecting water.

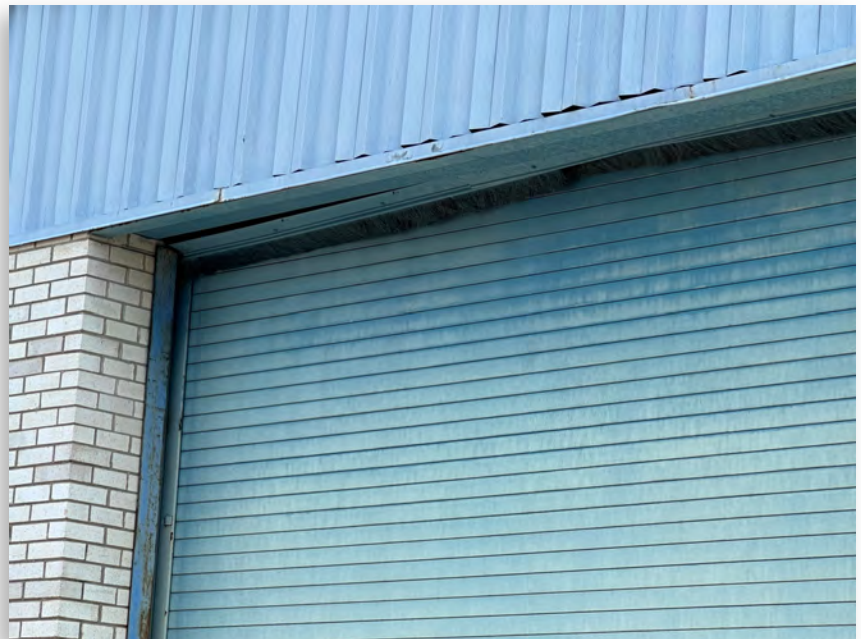
This detail of the same door shows a damaged sweep at the top of the opening as well as a portion of the metal panels that is not closed off properly at the bottom edge. The condition repeats in many places around the perimeter of the building. This may be due to differential expansion and contraction between the masonry and the panels.

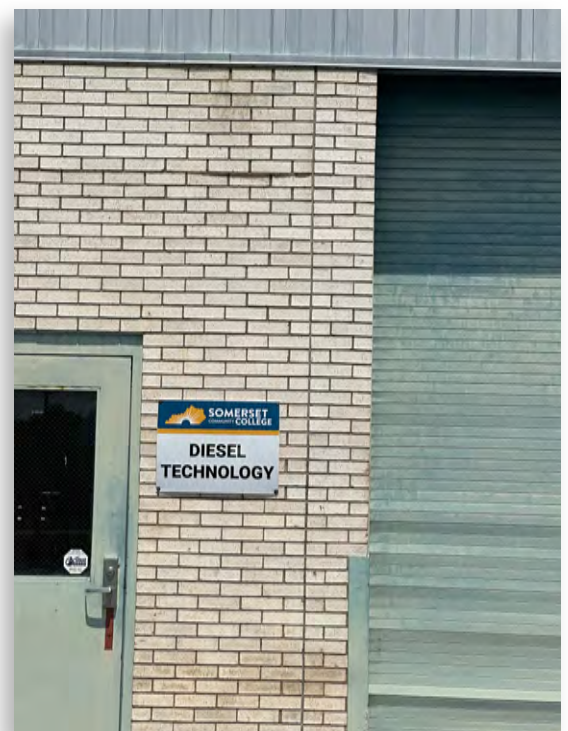
This photo of the parking lot side of the 1975 addition shows the expected expansion joint where the stresses in a brick wall are likely to cause damage to the bricks. However, this area again shows the issues with the relief angles 32" from the top of the brick (8 courses down) where the mortar has popped out of the joint. This issue with the relief angles is typical on all sides of the building.

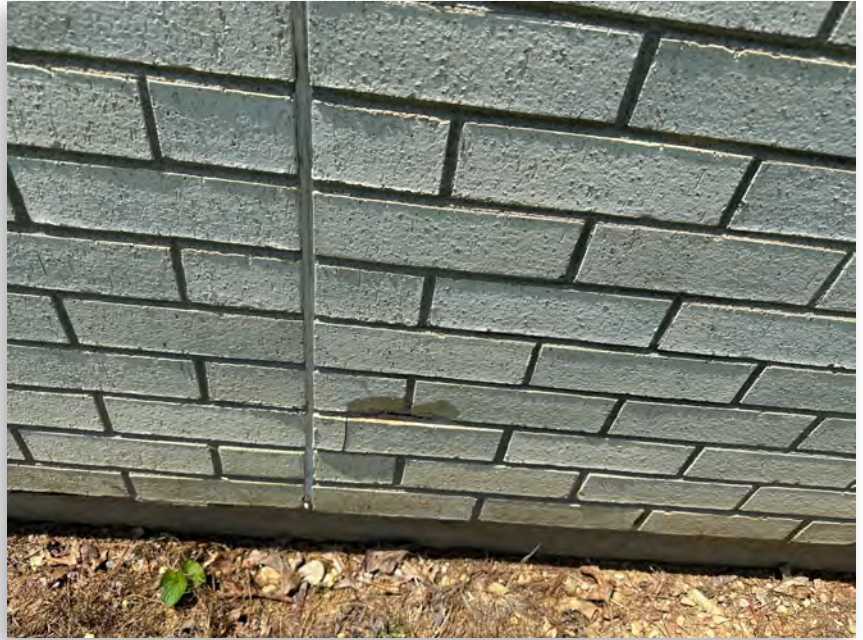
Even with properly located expansion joints, the expansion and contraction in the building is still causing bricks to spall and break. The image at right shows a broken brick on the right side of the expansion joint and two bricks above it with spalled faces.

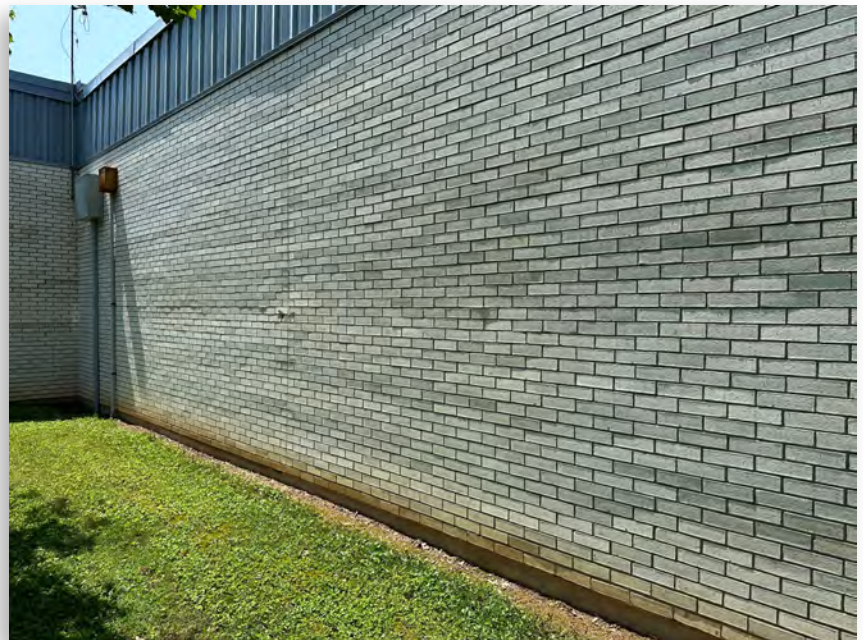
These deformations in the brick are subtle in most places and difficult to document. However, in this photo the undulations in the brick surface are fairly clear. The familiar horizontal striping associated with the relief angles is also evident.

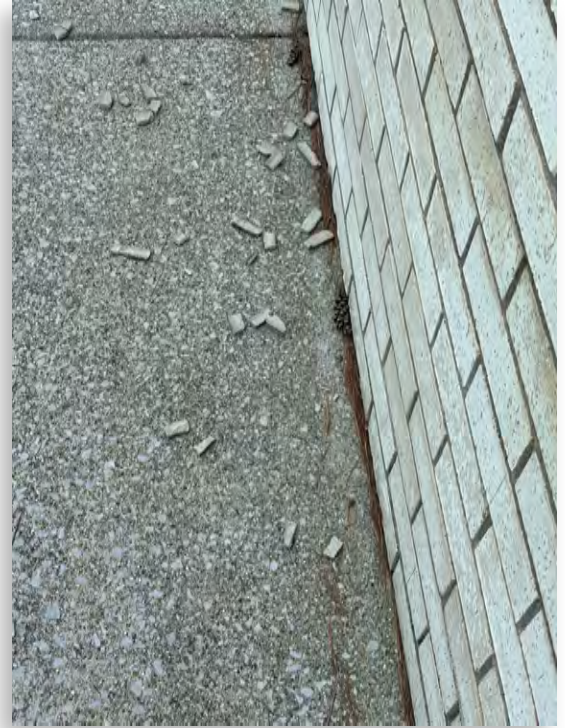
In the same area as the previous image, WPa found numerous fragments of mortar joints scattered on the sidewalk.

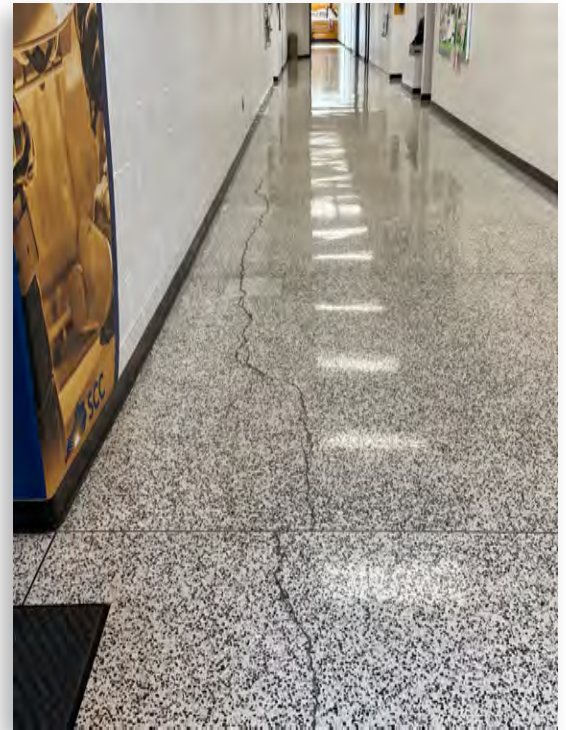
The main corridors in the 1971 building are terrazzo. The crack shown here runs the majority of the way down the wall separating the office/classroom spaces on the right from the open shop areas on the left. The building appears to be divided structurally along this line and there is an expansion joint on the roof directly above. This wall on the left side of the image is a bearing wall and has experienced some settling since the building was constructed.

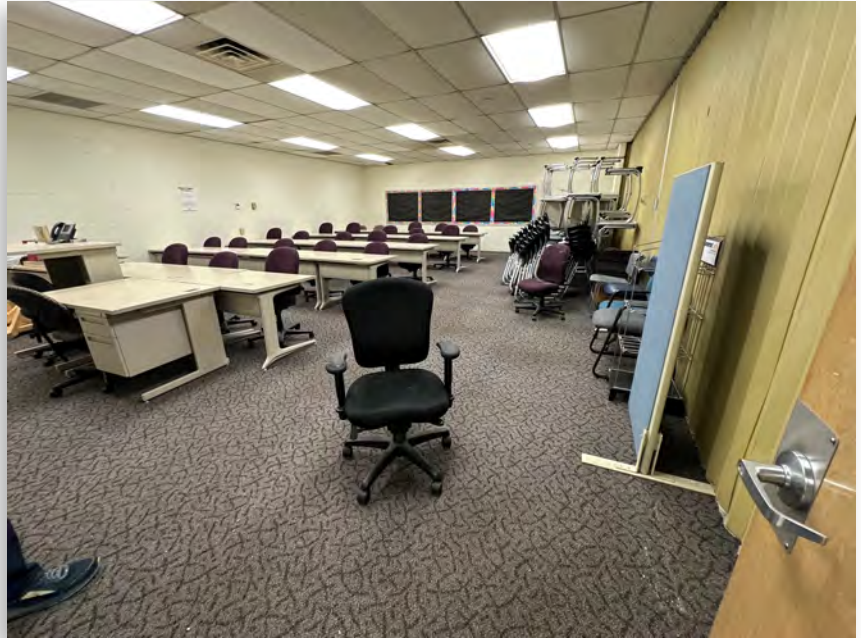
The interior finishes in many areas are dated. Ceiling tiles are sagging and discolored from the humidity and age. The accordion wall panel on the right of this image is in particularly bad shape. Many classroom spaces have no windows and poor lighting. Carpets are wall to wall and hold on to mildew smells, stains and wear in many areas.

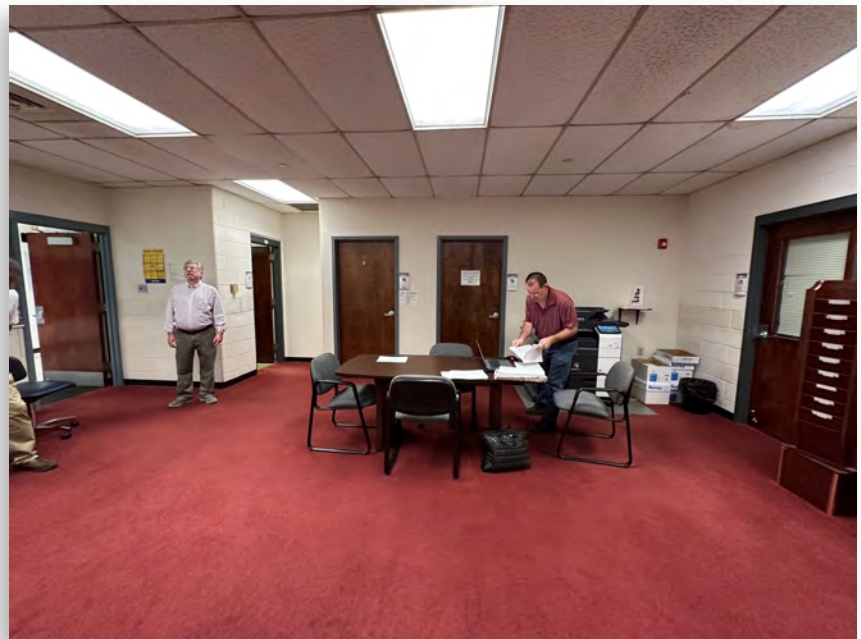
This area in the original building was renovated during the addition project in 1975. However, the sagging acoustical ceiling tiles, cut-pile carpets, and dated colors and finishes show the age of the space.

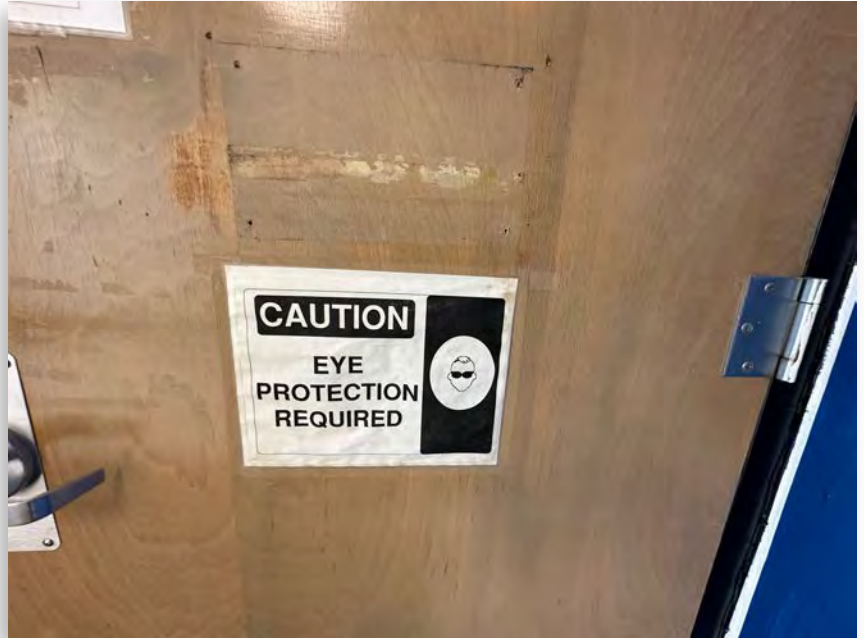
The interior doors on many spaces are in bad shape. Some doors are showing the effects of changes in humidity over 45 years, others have obvious water damage, and some are repurposed doors or doors that have been damaged through use. Interior doors need to be replaced to provide a consistent look and to ensure the right door is used for the space it serves.

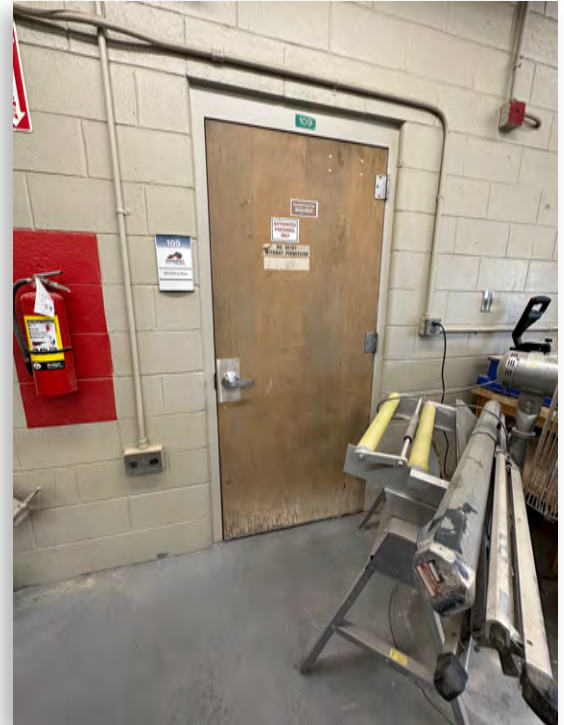
This door, in a shop area, has obvious water damage at the bottom. This is another example of doors that are inappropriate for their environment. Doors in areas like this should be hollow-metal and galvanized to protect them from elements.

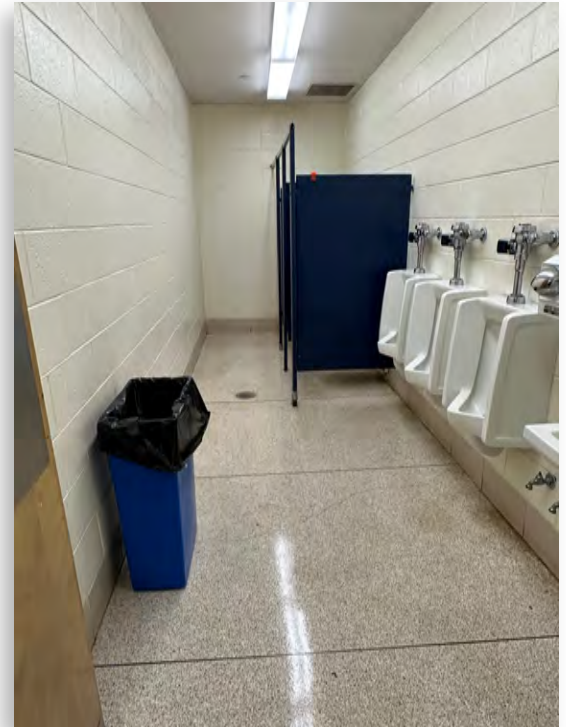
This restroom, behind the door in the previous image, is one of the largest restrooms in the building (fixture-wise). It contains half the required fixtures for males. At just 6'-0" wide it is almost impossible to make ADA accessible.

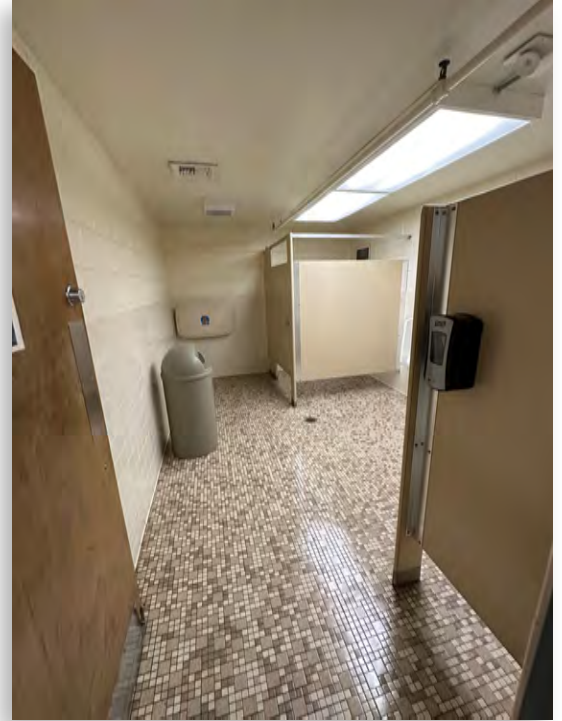
The accessible restrooms at 217A and 217B are actually in 217B and 217C according to the room plan provided to WPA. However, since there is no room signage outside the restrooms, it hardly matters. This photo of the men's room shows that it meets the bare minimum required for accessibility: One toilet, two urinals and two sinks. The lighting and finishes are well cared for but minimal.

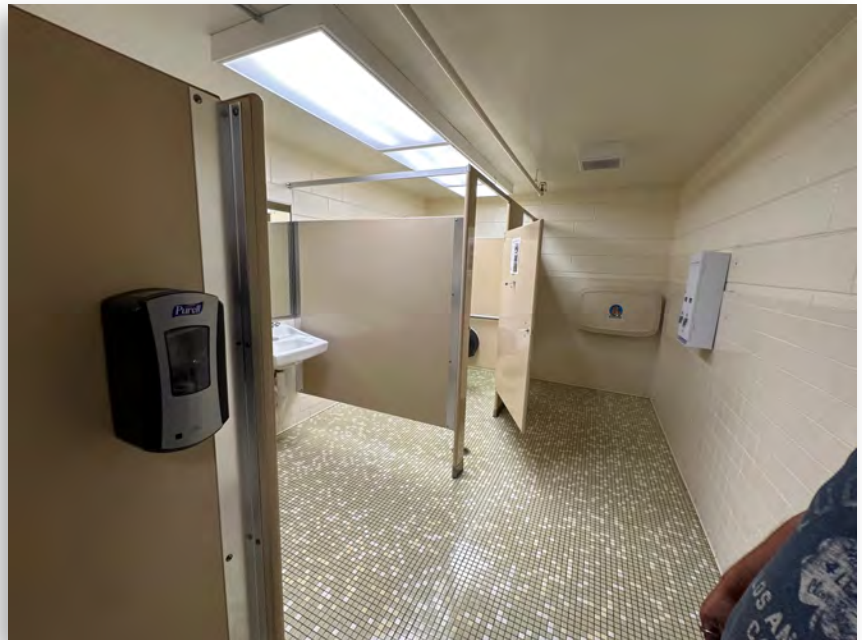
The women's room next door is similar in size and in its lack of lighting and minimal approach to finishes.

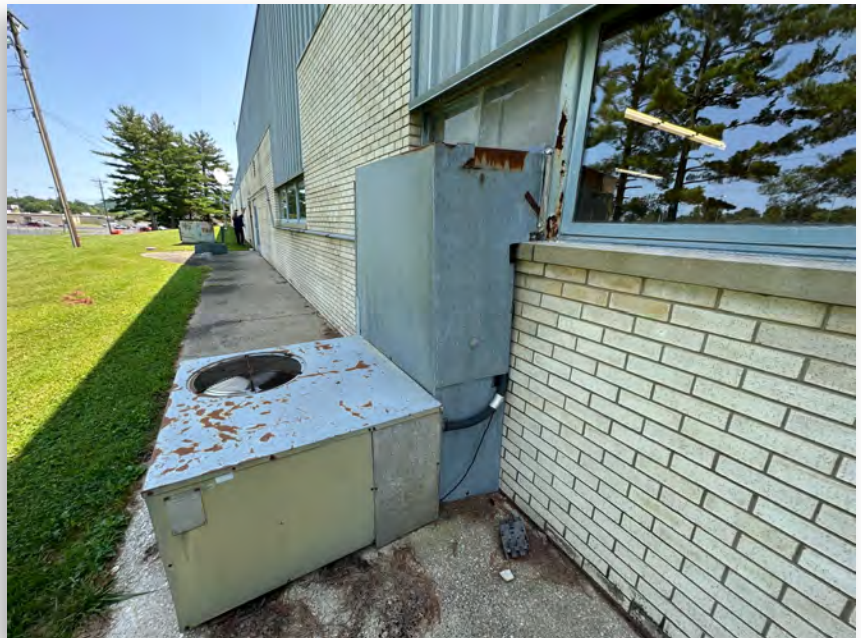
The photo at right is a good starting place for a discussion about the mechanical systems in the Laurel South building. This mechanical unit is serving the former masonry shop which has been converted into the electrical shop. The HVAC needs changed and this is how those needs were met.

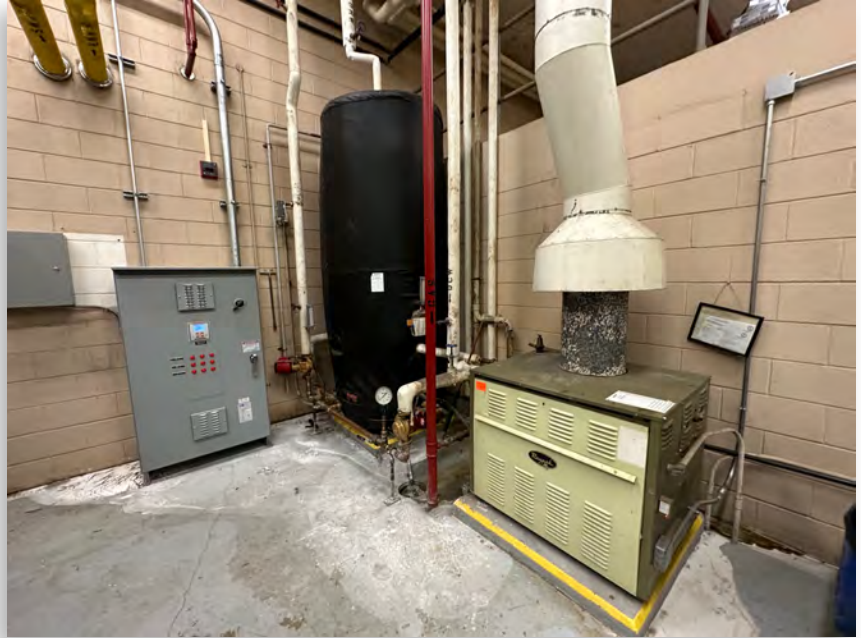
The photo shows the smaller boiler in the back of the mechanical room.

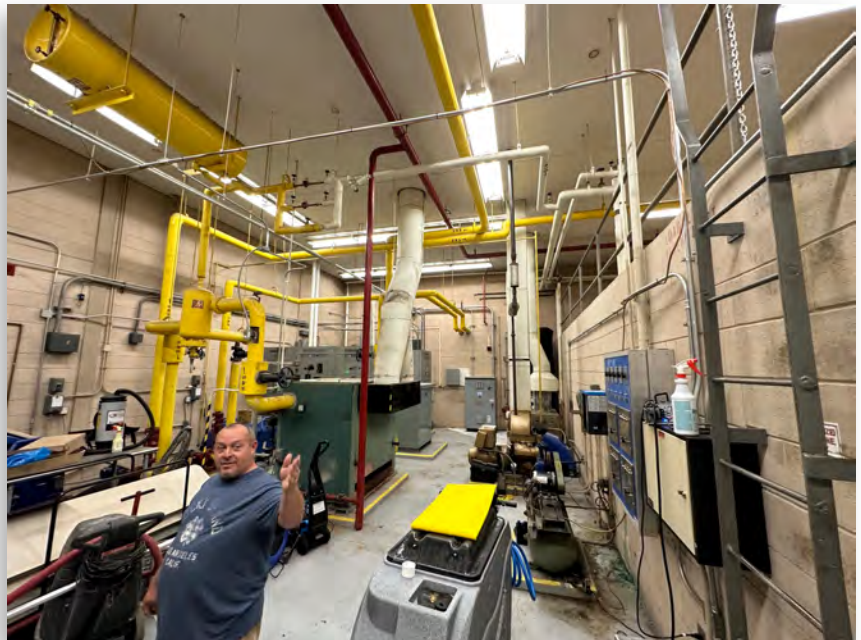
Another overview of the mechanical room in the 1975 addition.

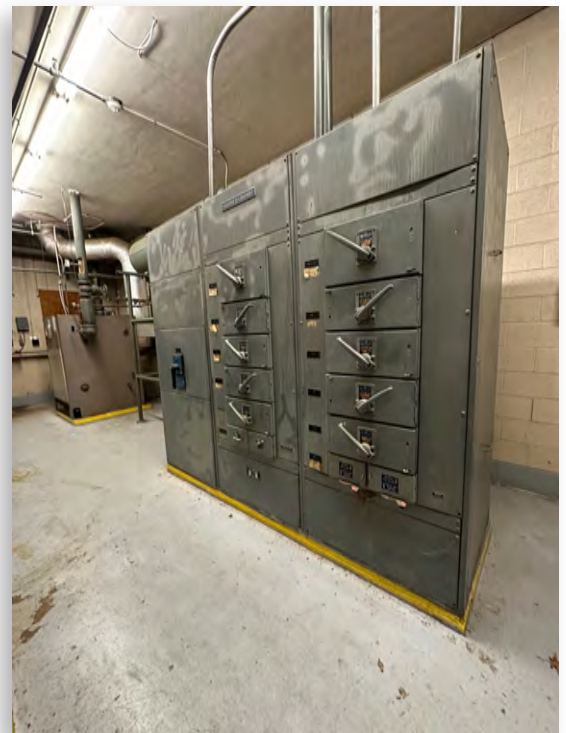
This view is facing the opposite direction. A boiler is visible behind the switch gear.

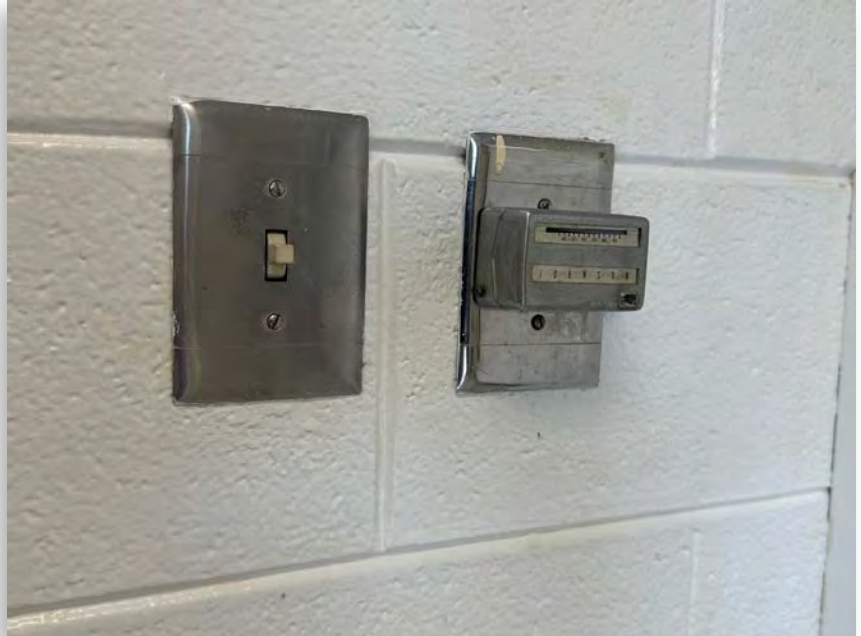
Lighting and HVAC controls are outdated and should be upgraded with the new mechanical units.

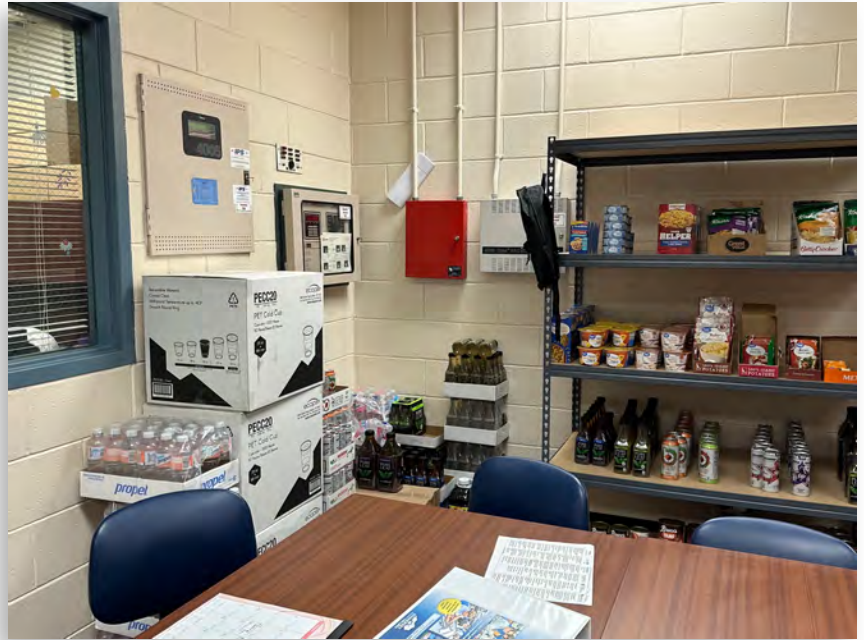
This photo shows the fire alarm and master clock panels against the back wall of the food pantry. The Simplex 2350 master clock system is no longer made. However some version of the Simplex 4005 Life Alarm and the 4009 IDNet NAC Extender appear to be available as recently as recently at 2021. WPa has been told that there have been no upgrades to the systems since the building was renovated in 1975.

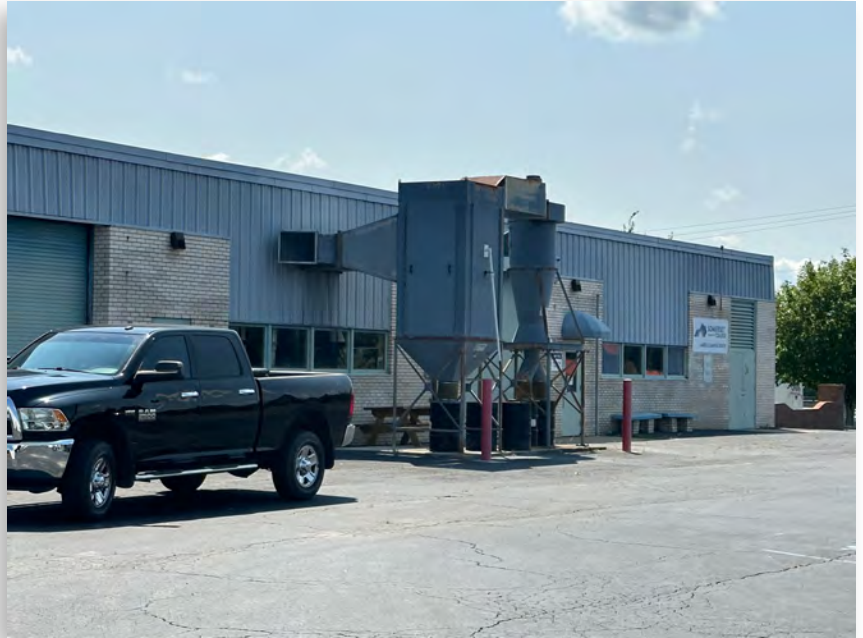
The Construction Technology Lab utilizes a sawdust collection and extraction system to collect sawdust from floor inlets and at various machines. These units exhaust the sawdust and deposit it in the barrels seen below the units. This system is aging and needs to be upgraded.

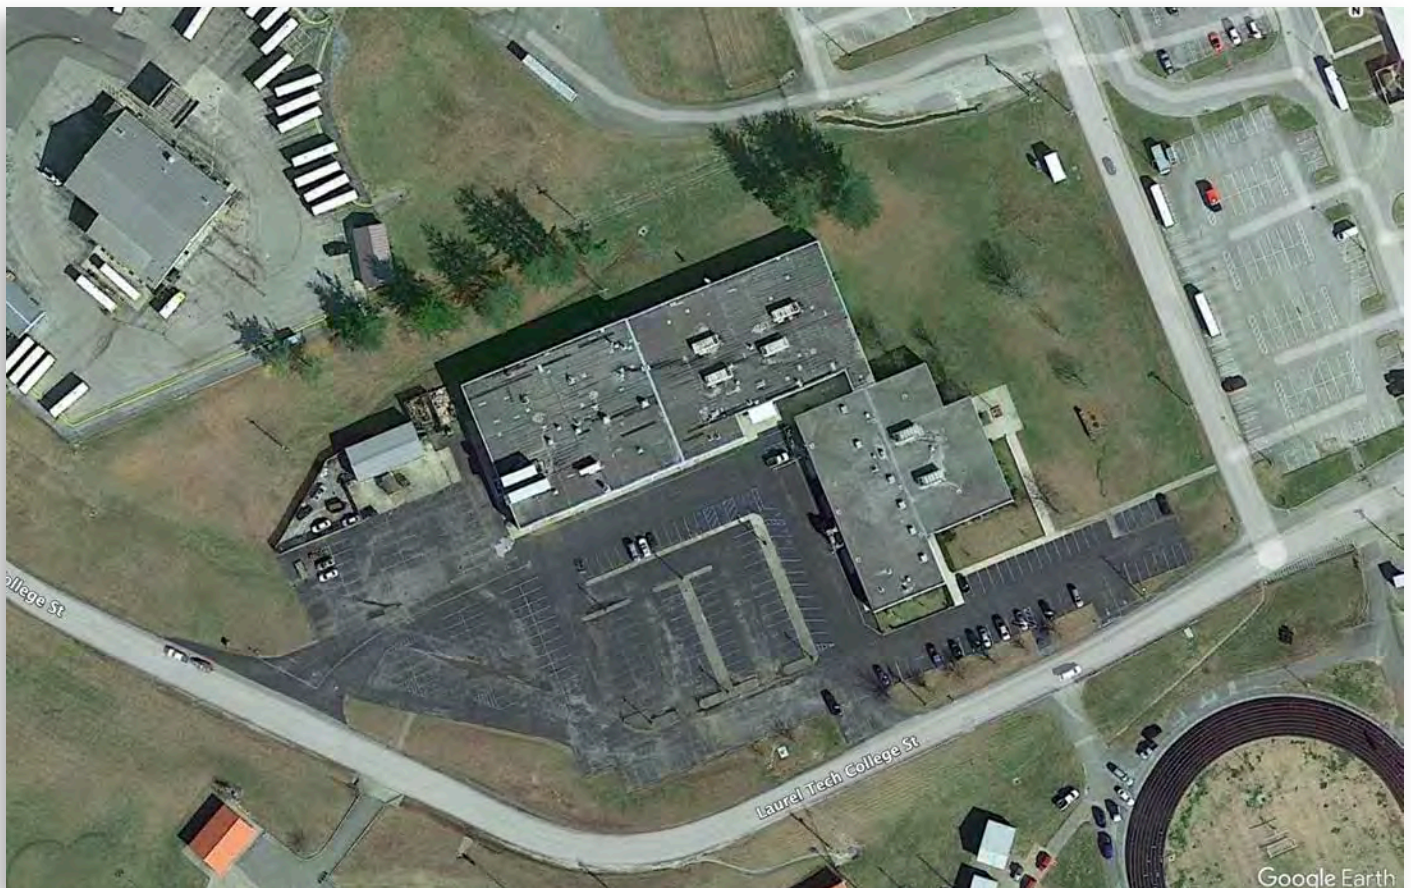
The Laurel South Campus showing the parking lot and drives.

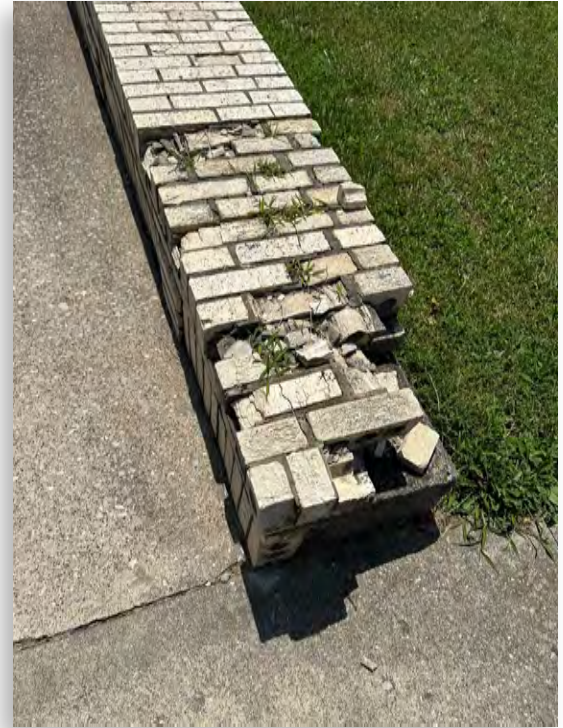
Brick landscape walls that are in bad shape need to be repaired or rebuilt depending on whether they are retaining walls or simply decorative like this one at the right.

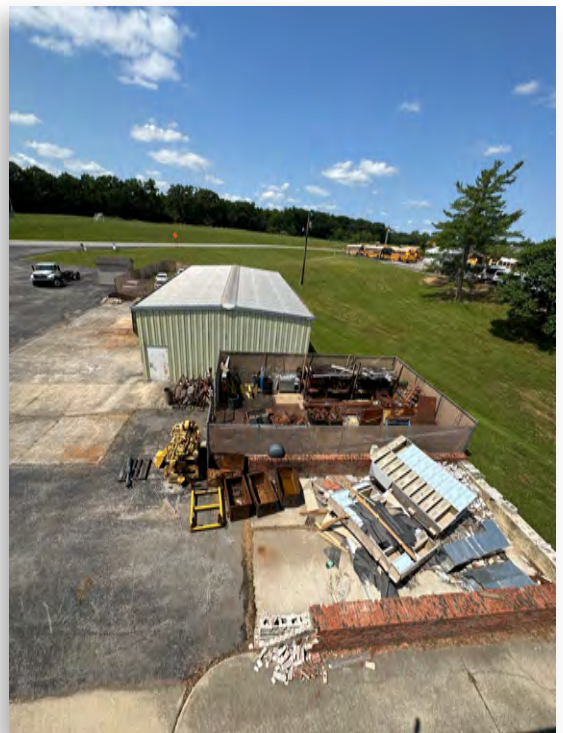
This view of the maintenance shed from the roof of the 1975 addition shows the need for new fencing and walls as well as the condition of the asphalt parking lot. The building itself seems structurally sound but could use a new metal skin and some improved shelving and storage inside as well as upgrades to insulation were needed and any heating units.

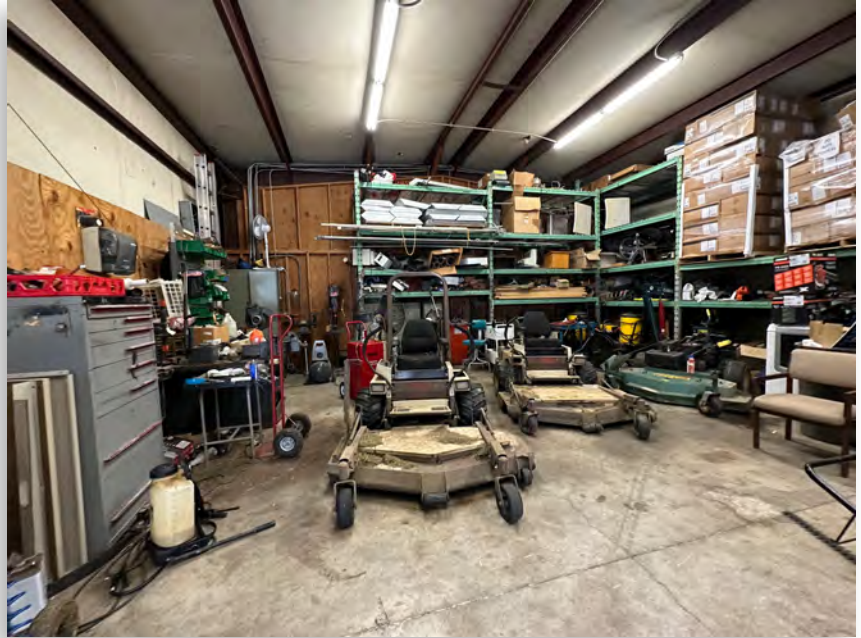
The right side of the maintenance building contains mowers and supplies for maintaining the site.
