KENTUCKY COUNCIL ON POSTSECONDARY EDUCATION
FINANCE COMMITTEE MEETING

TITLE: Proposed Raze and Replace Asset Preservation Pool Project:
Somerset Community College, Laurel South Campus, Phases I and II

Laurel South Feasibility Study

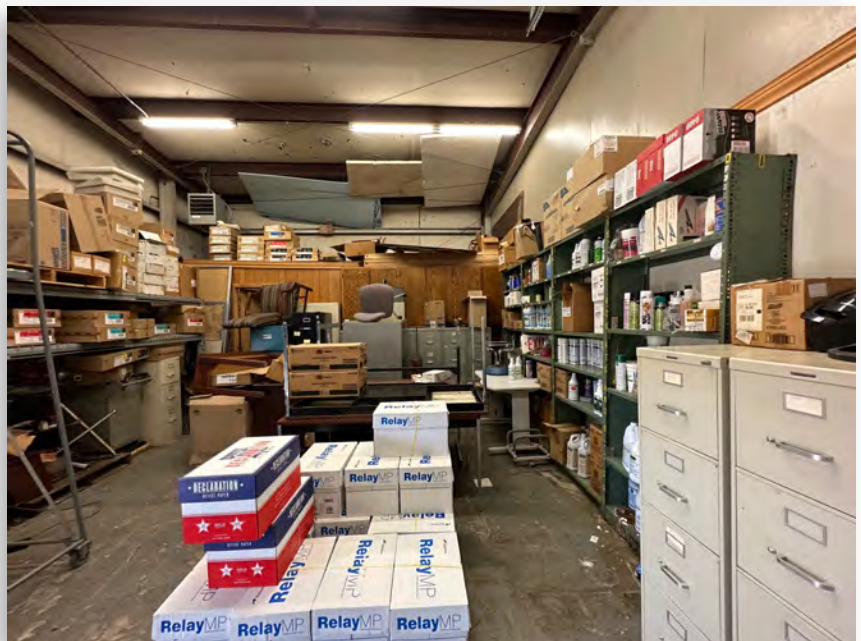
The left side of the maintenance building contains supplies for the building and its upkeep.

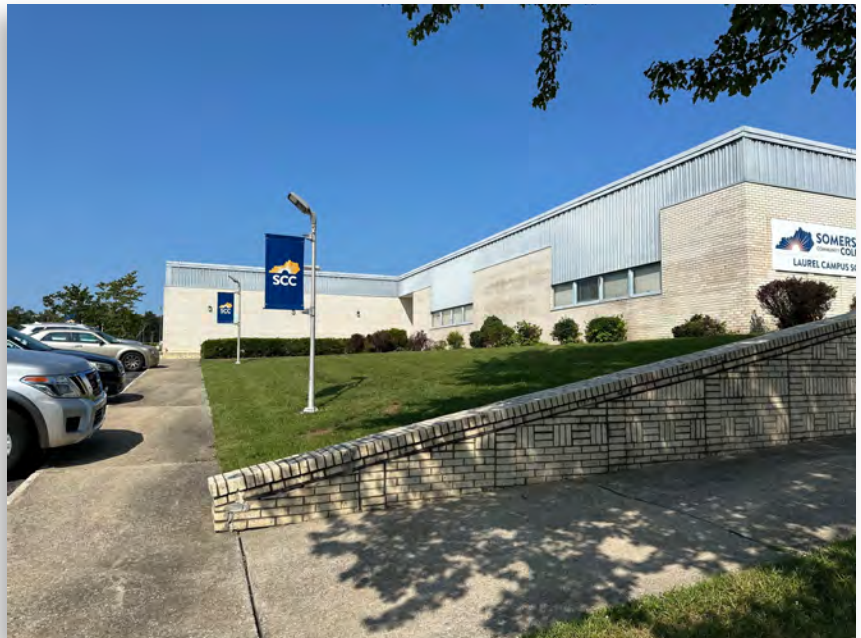
This retaining wall along the sidewalk leading to the main entrance is in disrepair. The wall has cracked and spalling bricks, damaged mortar joints and significant discoloration as it leads visitors up to the lobby.

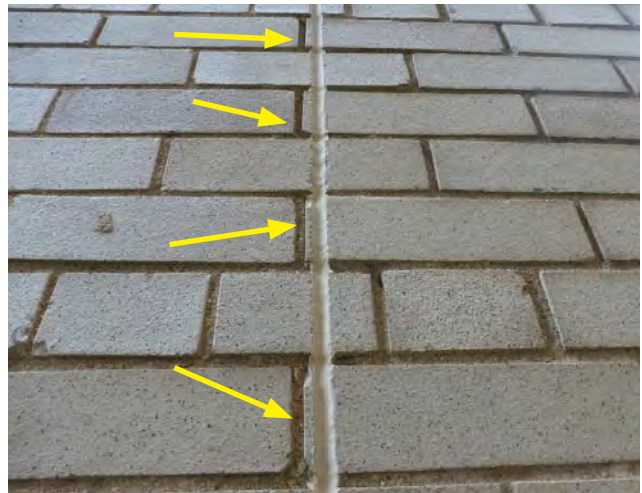
Photo 2
Poorly Aligned Remedial Expansion Joint

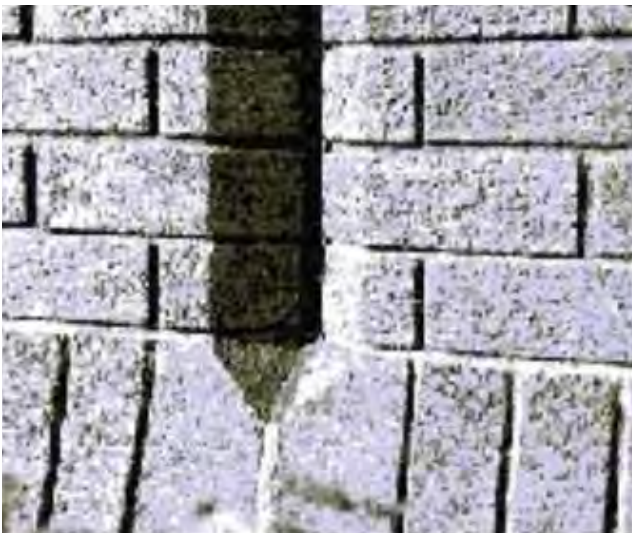
Photo 3
Accentuated Expansion Joint

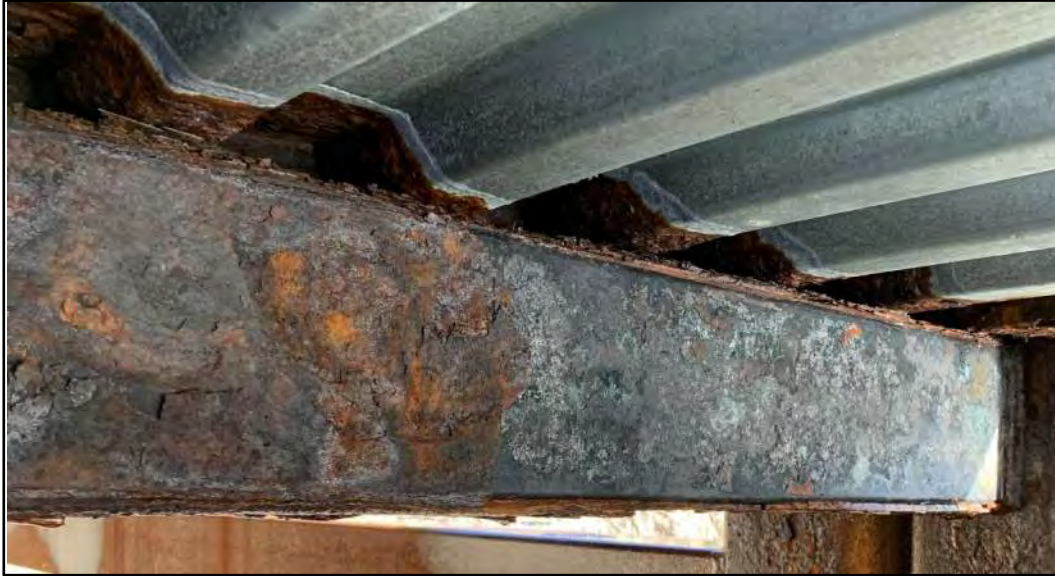
Image 2: Delamination Removed from Cross Member

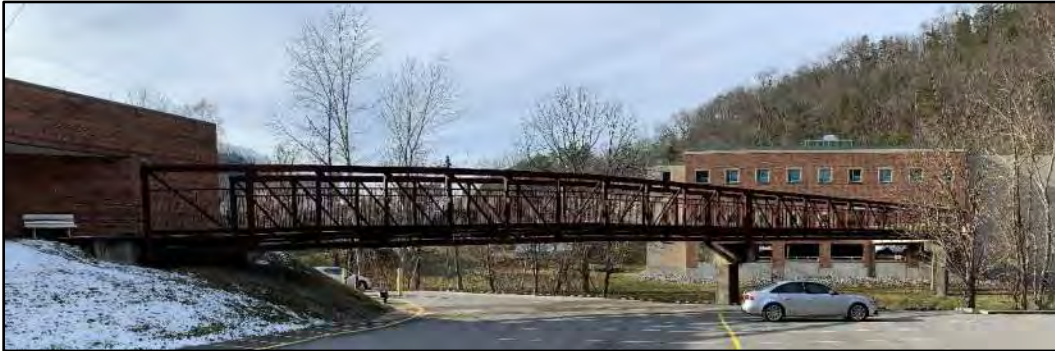
Image 3: Bridge East Elevation

The existing pedestrian bridge is a two-span steel pratt truss between the Mason Academic Building and the Hogg Allied Health Center. The truss has HSS8x8 top and bottom chords, HSS5x5 verticals and HSS3x3 diagonals. Each truss is connected together with HSS6x4 cross members and HSS3x3 lateral bracing below the concrete slab on deck to provide lateral buckling stability. The bridge has an open top with tabs welded to the vertical members for the attachment of a roof. The existing drawings call for the roof to be an alternate; no roof was installed at the time of our inspection. All steel tube members are welded together all around. Steel guardrails are constructed using channels and rounds steel rods for the entire length of the pedway. All steel has a weathering finish. Weathering steel is installed as “raw” steel and allowed to rust. The rust performs a protective coating to the elements. The bridge is spliced with bolted splice plates at two locations, the mid span of each span.

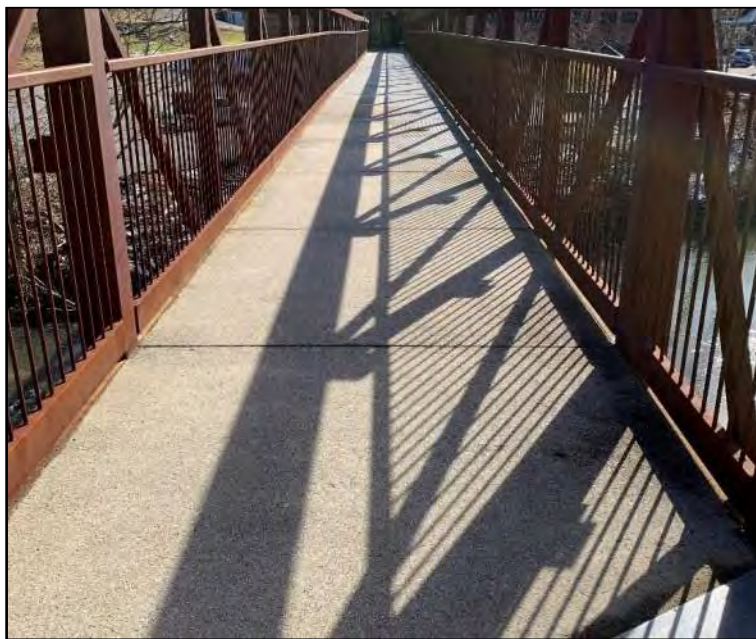
Image 4: Bridge Walking Surface

The walking surface is exposed concrete with no apparent sealer or traffic membrane. The concrete surface has a broom finish with sawn construction joints at ~7'-6" on center with no sealer in the joints. The walking surface is constructed with 2 1/2" concrete over non-composite 1 1/2" galvanized metal deck (4" total thickness). The bridge spans between concrete abutments and piers with no apparent sealer applied to their surface. The Southeast span (~80'-0") is over a parking lot and the Northwest span (~100'-0") is over the North Fork Kentucky River. The height to the underside of the bridge ranges from ~7'-6" at the Southeast span and ~17'-9" at the Northwest span. Photographs of the bridge and its components were taken, some of which are included herein.

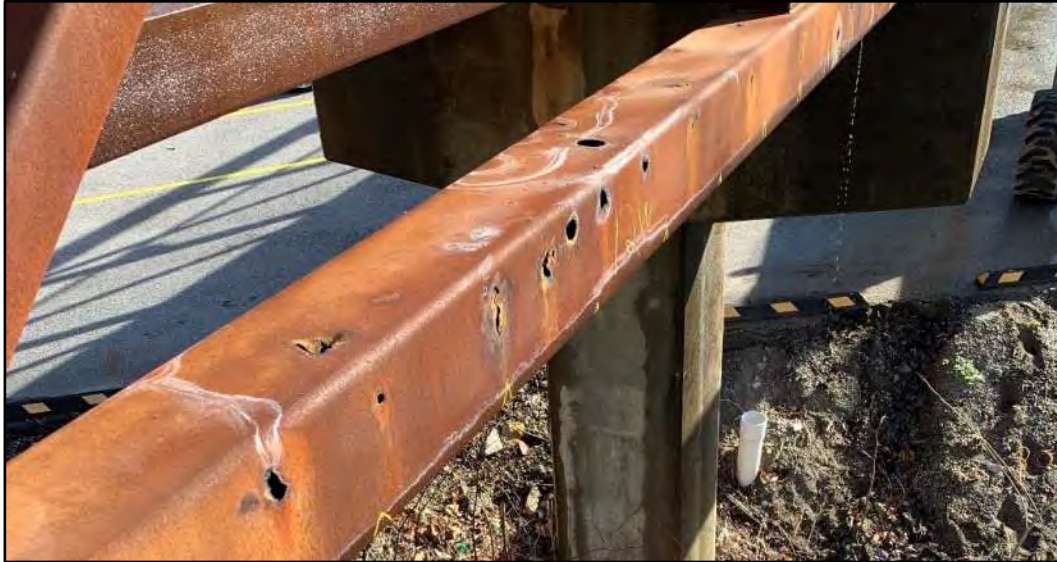
Image 6: Span 1, West Bottom Chord Deterioration

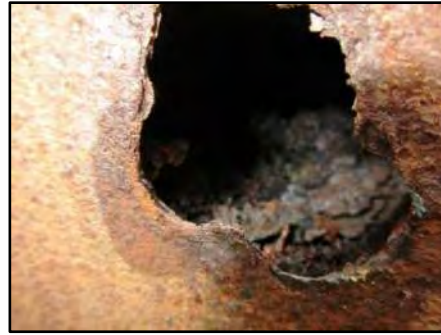
Image 7: Close-up of Holes through Bottom Chord

The truss bottom chords are in moderate to poor condition. The truss bottom chords have consistent mild delamination on the underside of the tube for the full length of the bridge on both chords. Localized corrosion resulting in significant loss of section was found in the West bottom chord of both span 1 (North span) and span 2 (South span). In span 1 of the west bottom chord holes through the section are located on the outside face and on top of the tube. Holes range from 1" to 3" diameter spaced approximately 8 inches on center over a length of approximately 40 feet. Span 2 has holes approximately 1 inch in diameter spaced at 12 inches on center over 15 feet. The spacing of the holes is random, the above spacing is approximate. Weep holes are not present in the bottom chords, resulting in water to be retained in the closed section. Approximately 5" of water and ice was retained in the bottom chord at the time of our site visit.

We believe this is caused by the improper drainage of the walking surface above. The salt/water combination is draining onto the top of the steel bottom chords and causing the chords to rapidly deteriorate. Also, the bridge generally slopes to the west side of the deck, causing the water to drain to the West chord more than the East chord.

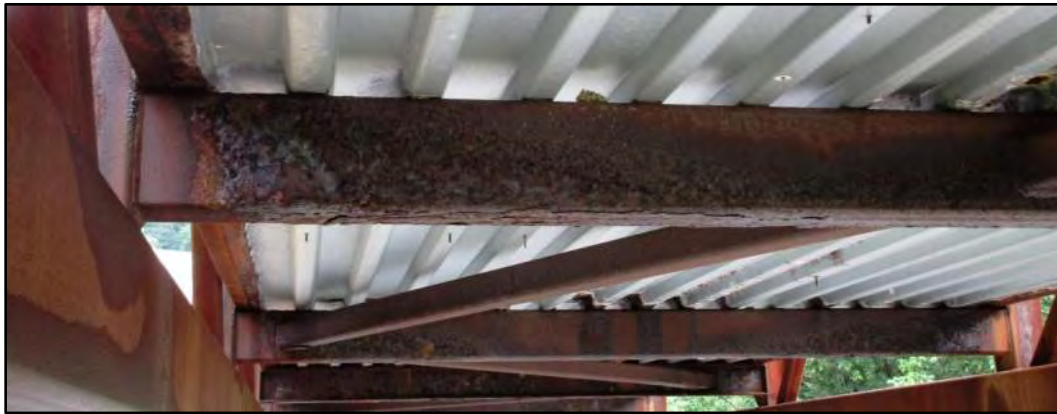
Image 9: Cross Member Corrosion

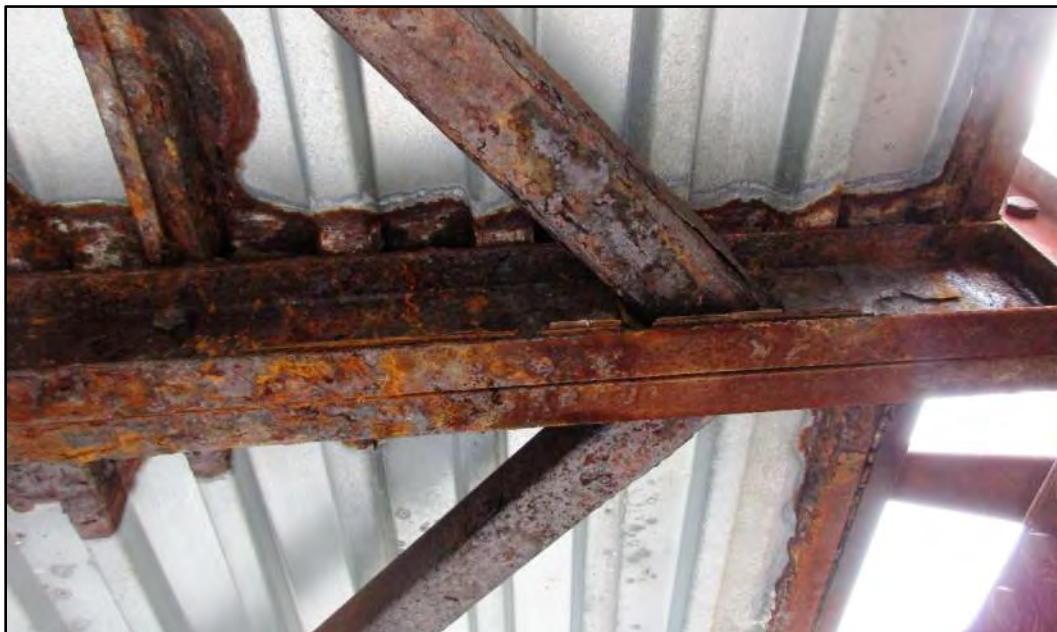
Image 10: Lateral Bracing Corrosion

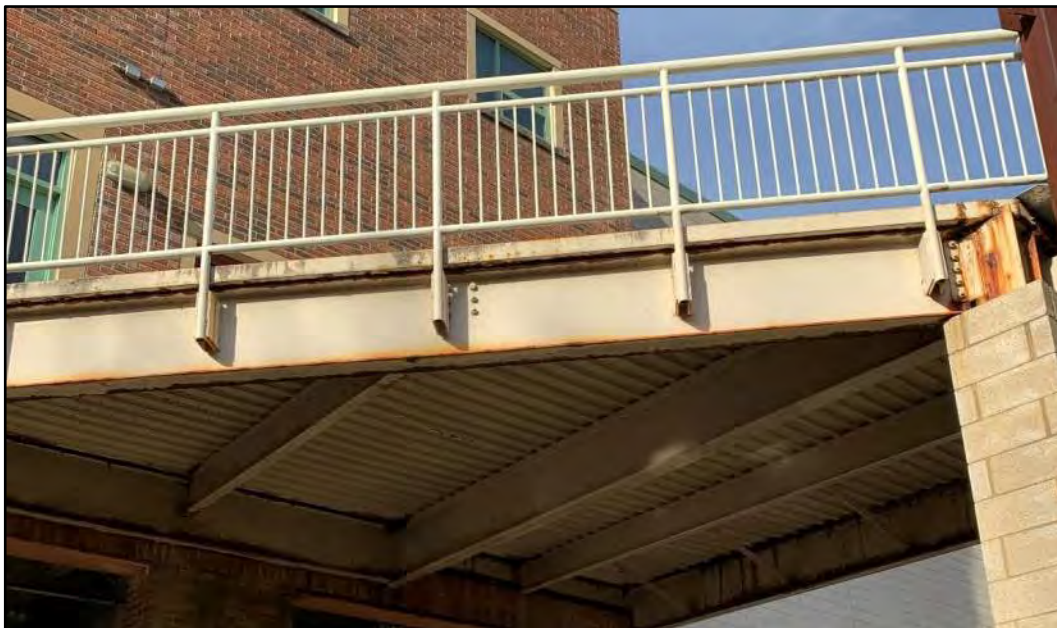
Image 15: North Raised Landing

The condition of the landing is fair. The steel beams are showing mild section loss due to corrosion of the top and bottom flanges around the perimeter of the landing. Some localized corrosion was observed at the underside of the deck and at bearing conditions resulting in approximate 90% section loss of the steel deck. The edge angle is experiencing surface rust where it is in contact with the beam top flange.

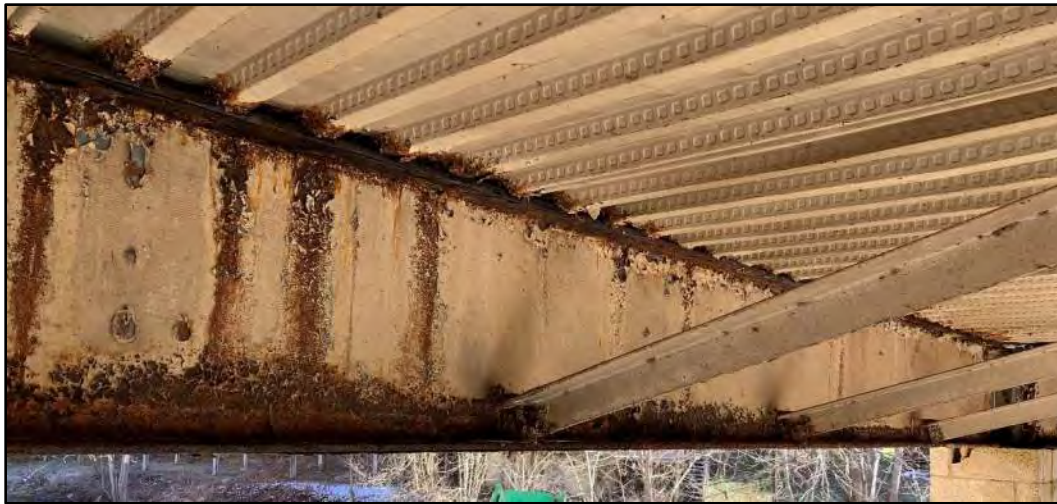
Image 16: North Landing Underside Corrosion

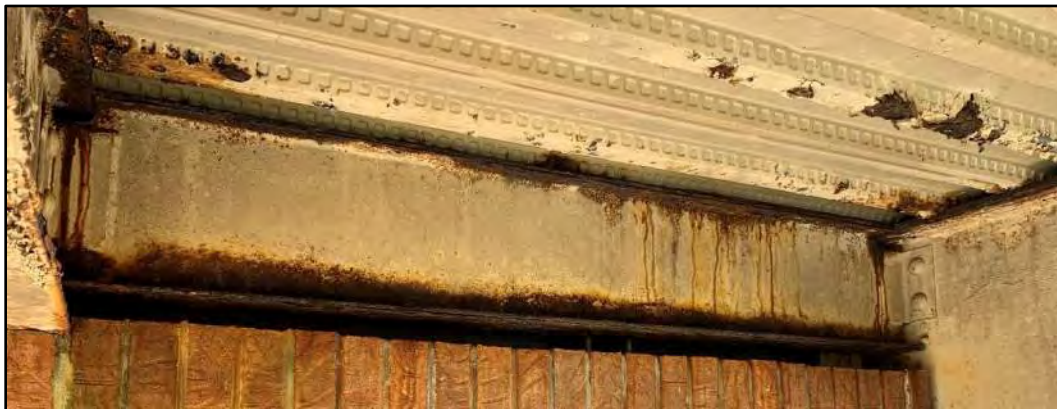
Image 17: Beam Corrosion at Building Intersection

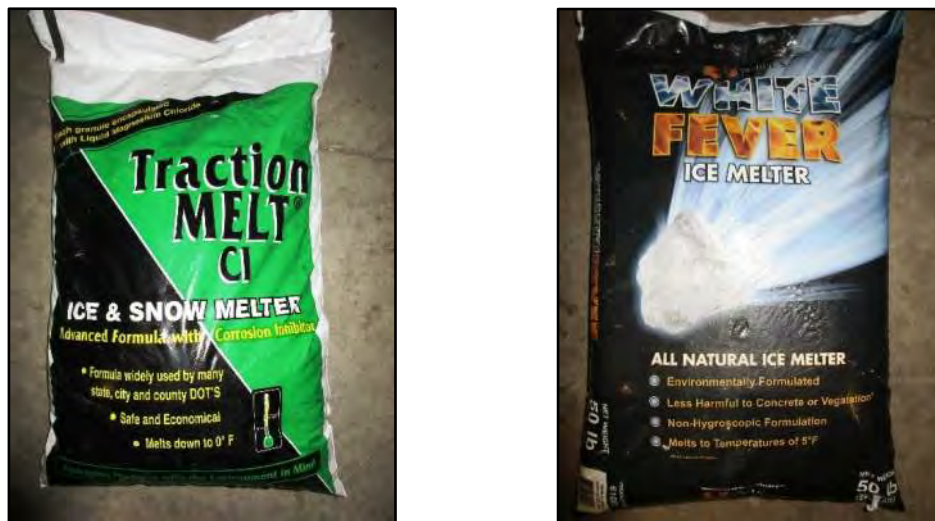
Image 18: De-icing Salts
